## November 2009 Electrical Safety Occurrences

# Electrical Occurrences by Month & Secretarial Office

(Rolling 18-Month Chart)

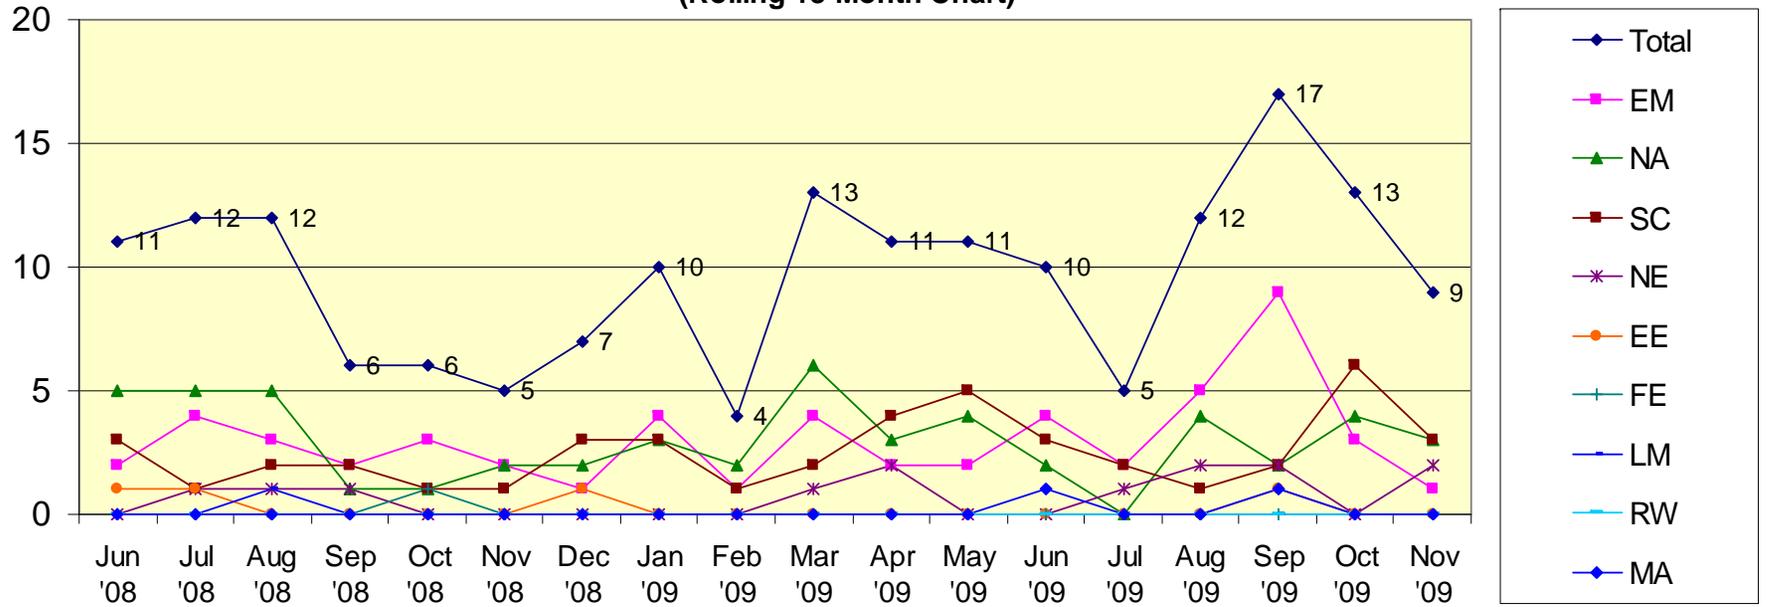
EE - Energy Efficiency and Renewable Energy, EM - Environmental Management, FE - Fossil Energy, LM - Legacy Management, MA - Management, NA - National Nuclear Security Administration, NE - Nuclear Energy, RW - Civilian Radioactive Waste Management, SC - Science
