September 15, 2010

“Near Catastrophic Event” At Watts Bar Proves the Need for Stronger Human Performance Tool Use

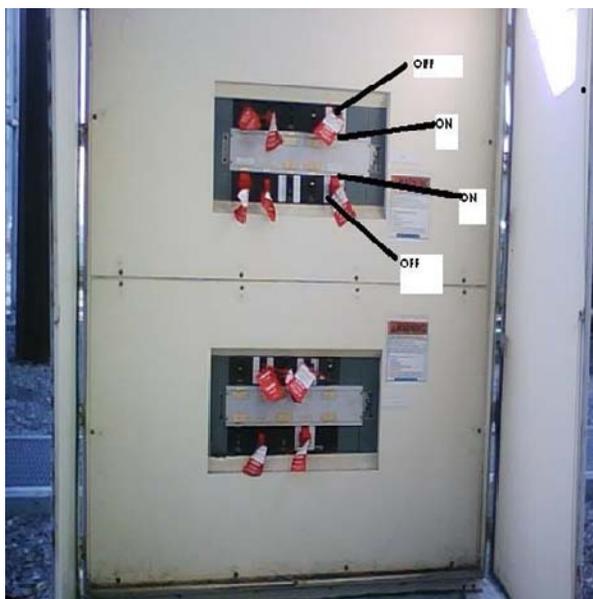
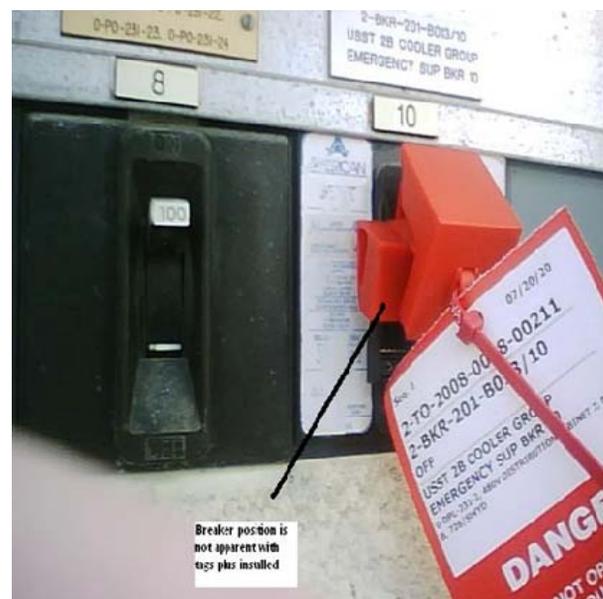
An investigation into the event has determined that the operators involved in placing the tags did not recognize that the electrical breakers in question were mounted upside down in the cabinet nor did they perform **STAR** to verify their actions were correct even though the breakers were mounted upside down. The **ON** and **OFF** position indications are clearly labeled on the breaker. The operators placed the tags on the breakers in the ON position rather than the OFF position. Another significant breakdown occurred when a “concurrent verification” performed by a second operator failed to identify the human error. It should be noted that independent verification is the correct verification process to be used and the use of **STAR** would have caught the issue during the implementation of the clearance.

There is clearly an opportunity to learn from this event and ensure electrical equipment is properly tagged prior to performing this type of evolution correctly. The breaker position while different is visible and as such requires going slowly and using proper verification techniques. The event demonstrates the critical importance of using our human performance tools to protect ourselves, our friends, our co-workers, as well as the plant. It also demonstrates why you never assume equipment is safe to work on just because it is “tagged out.”

Had the workers used Touch STAR, this event would not have occurred.
